Ms. Thomason  
The Parkwood Condominiums  
233 SW 154<sup>th</sup> St.  
Burien, WA 98166

RE: Roofing Analysis for 233 SW 154<sup>th</sup> St,  
Burien, WA.

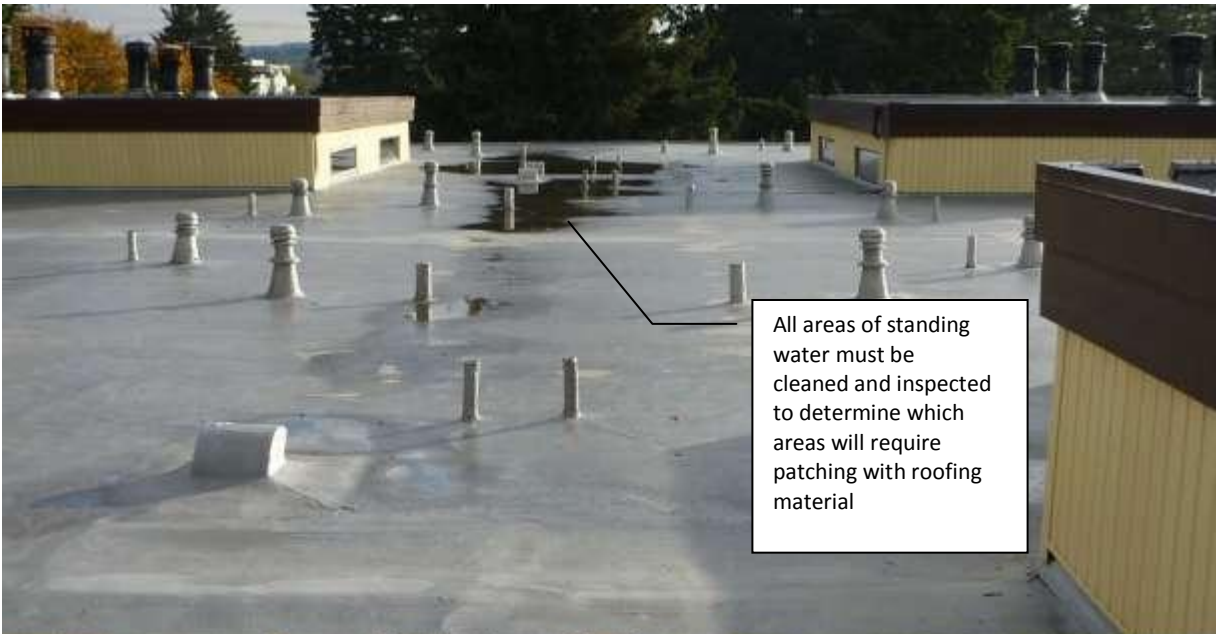
All areas of standing water must be cleaned and inspected to determine which areas will require patching with roofing material

- 1. All failed roofing areas a noted above and as located by the roofing contractor must be repaired or replaced as is found to be required.**
- 2. All areas of active leaks as located must be repaired as found to be required by the roofing contractor.**
- 3. Remove all standing water from the roof and located and properly repair any failing roofing material including all previous areas of patching.**
- 4. Locate and repair all localized areas of roofing failure.**
- 5. Seal all roof penetrations including all waste stacks, chimneys, vent, etc.**
- 6. Complete all repairs as located in the diagram above.**
- 7. Repair the damaged cap flashing at unit 310.**
- 8. Complete any other repairs required to stop all active leaks as found to be required by the roofing contractor.**
- 9. Complete all repairs required at all chimney / roof penetrations to ensure all active leaks are repairs.**

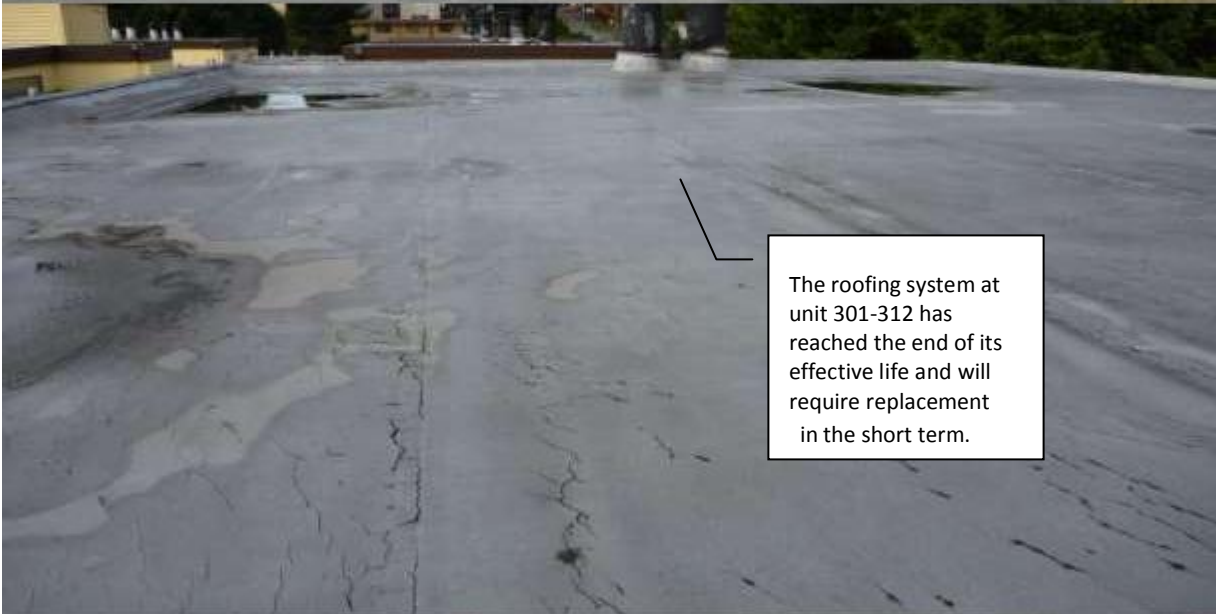
The roofing system at unit 301-312 has reached the end of its effective life and will require replacement in the short term.

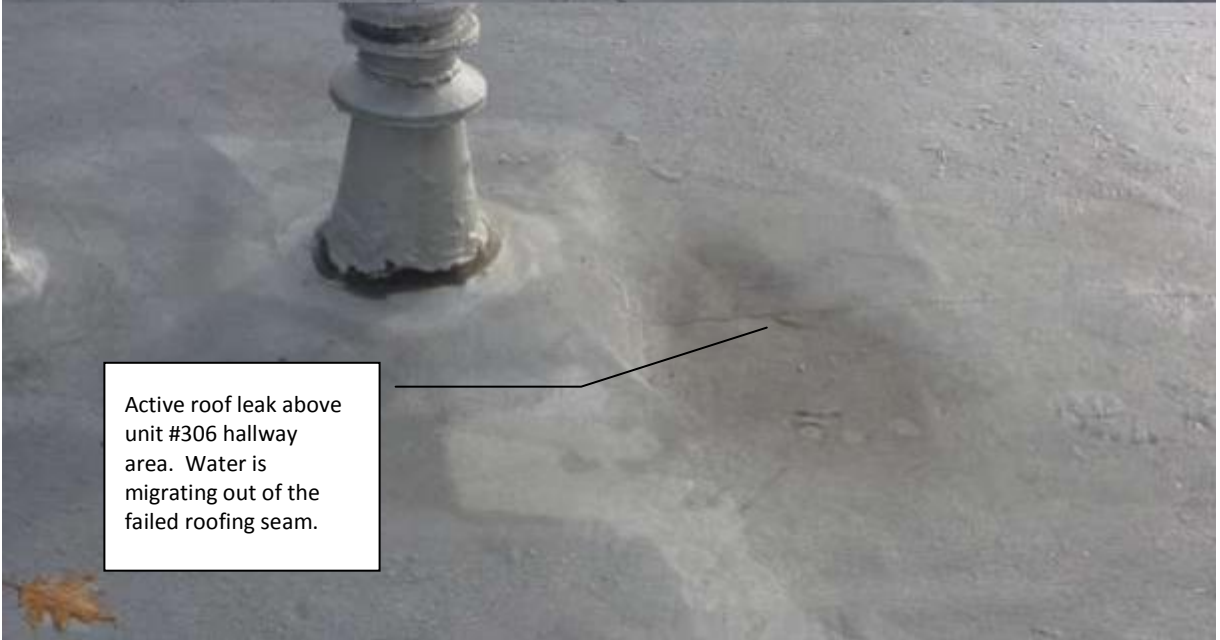
Active roof leak above unit #306 hallway area. Water is migrating out of the failed roofing seam.

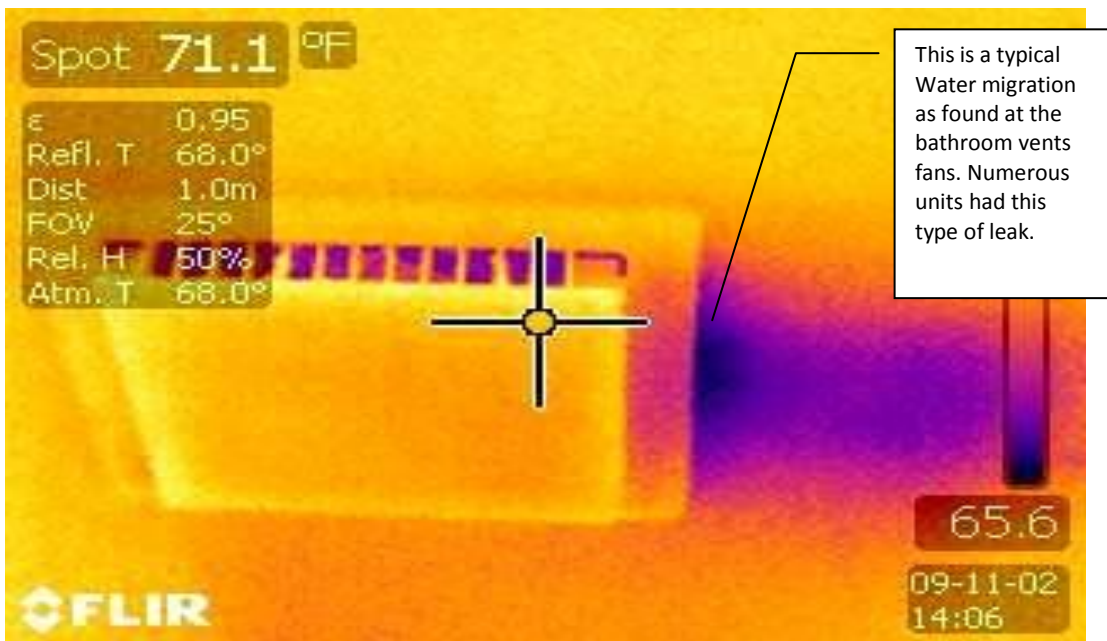
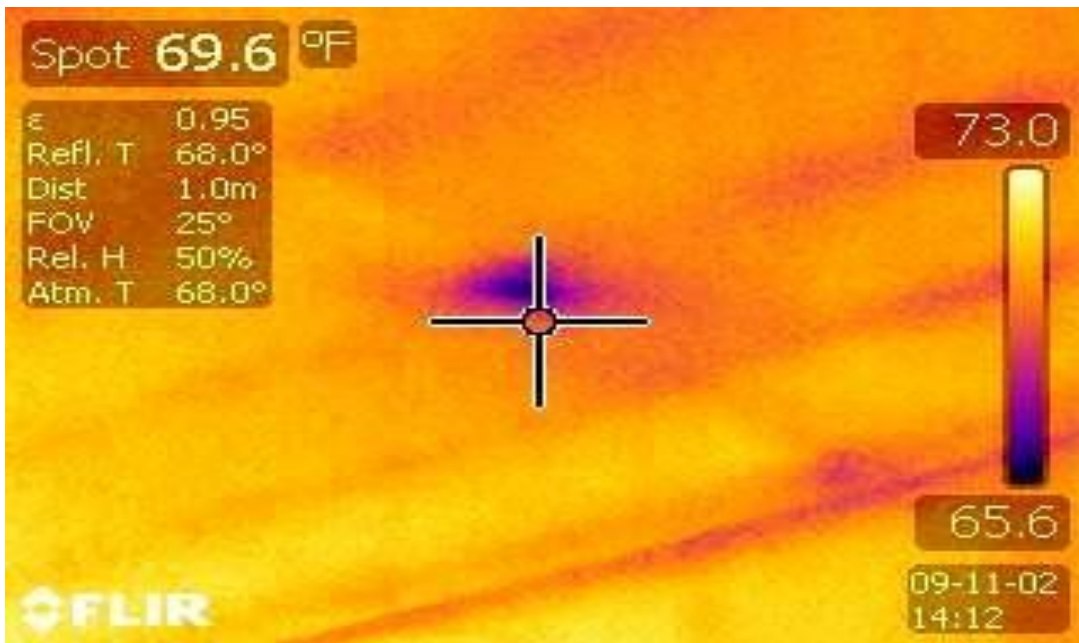
Limited areas of roofing failure and water migration were found throughout the building as shown below in the infrared thermographs and in the drawing outlining the specific areas of water migration.

Most of the areas of concern are small enough in area and have very limited areas of minor water migration and do not require removing any finish work unless further damage is found during the roof surface repairs.

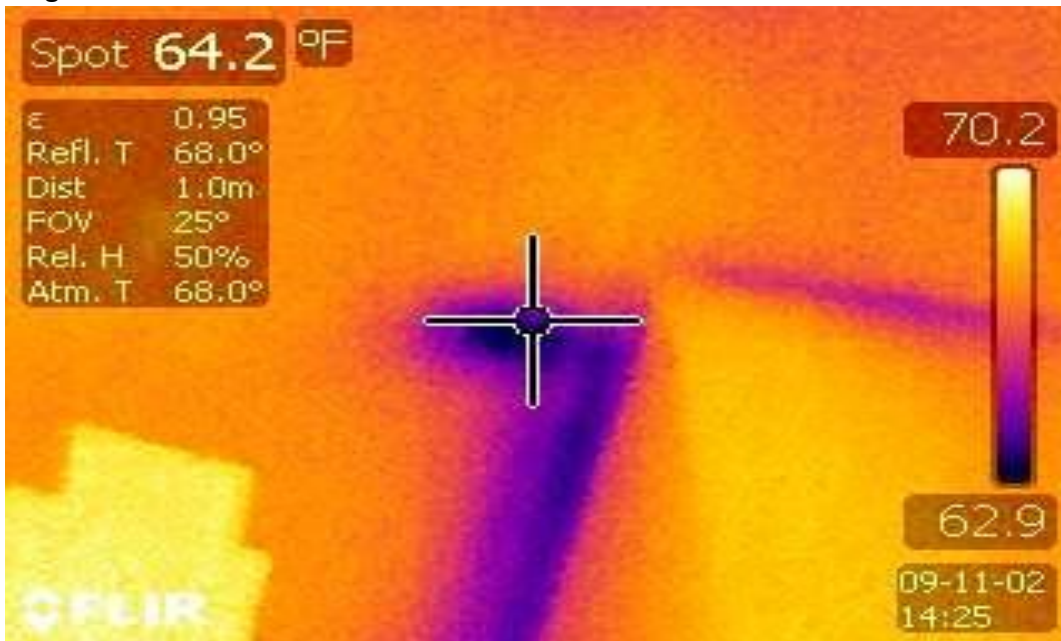
The areas of the interior finish work that show signs of water migration were generally very small, in the two to three inch diameter range. The specific areas are soon in the diagram below.

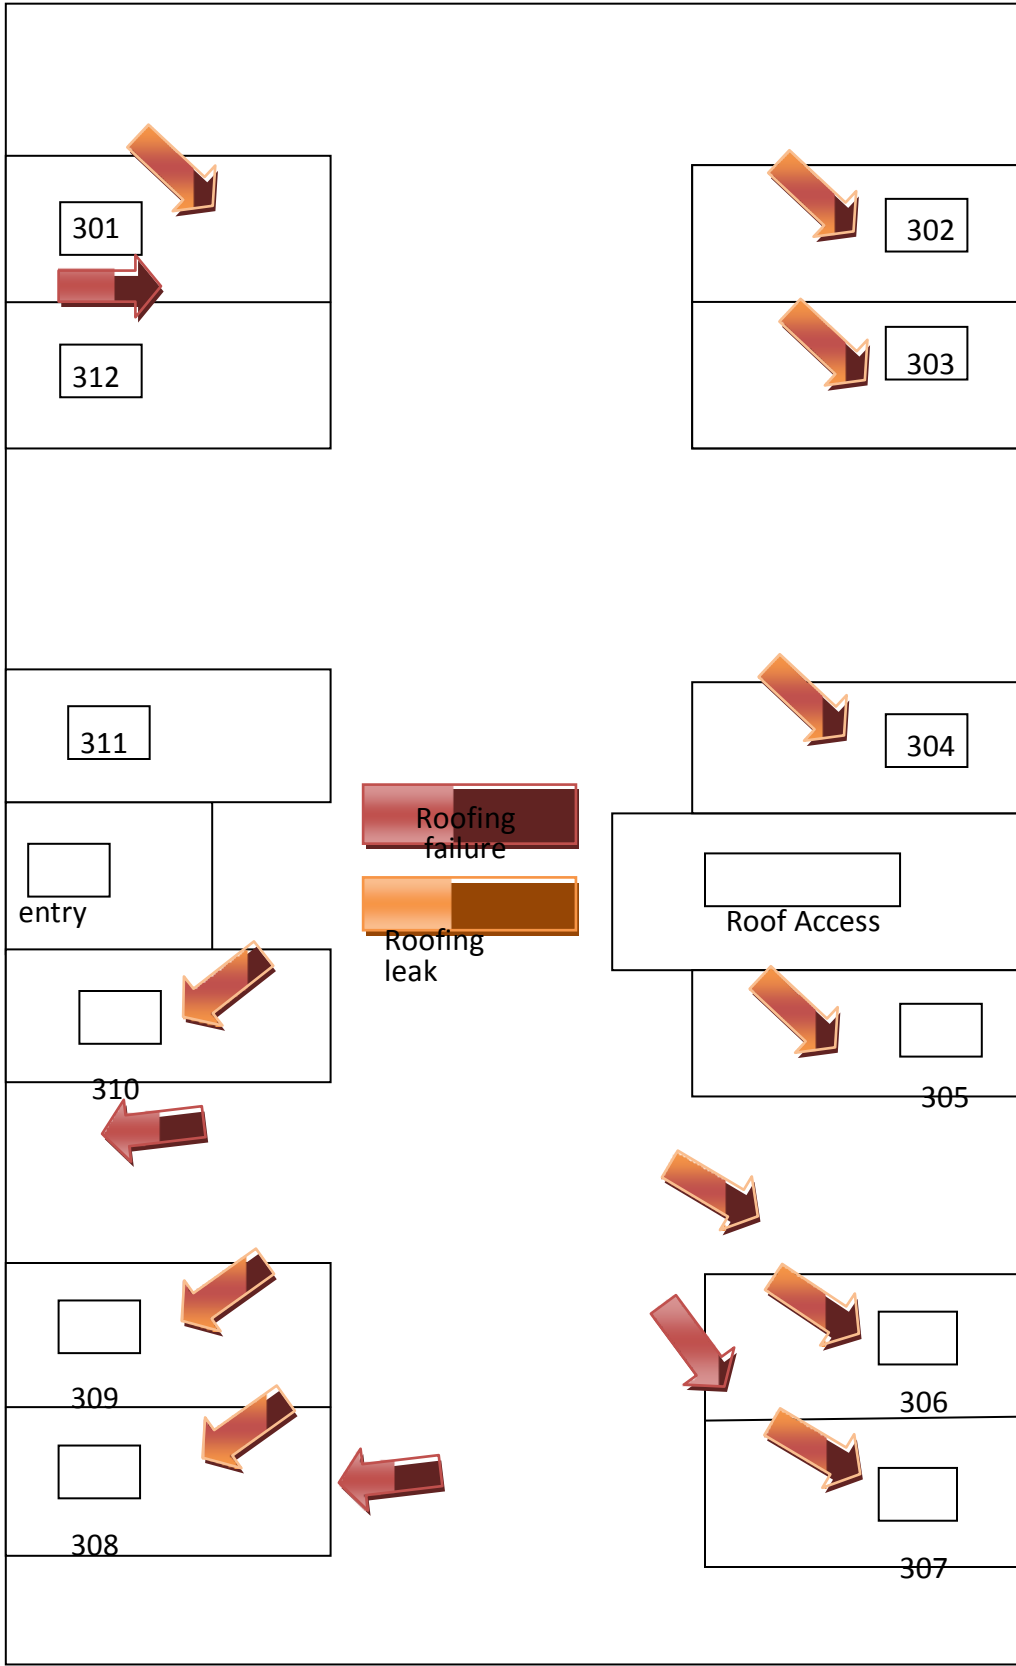
The areas around the chimneys at units 301, 312,302 were found. See corrective actions listed in this report for the repairs required.

<b>Unit # 306: Location of damage</b>	<b>ACTIVE</b>
<b>Unit # 306: Bedroom hallway/bathroom fan</b>	<b>ACTIVE</b>
<b>Unit # 301: SW corner of living room/to the right of bath fan</b>	<b>ACTIVE</b>
<b>Unit # 302: N side of chimney chase</b>	<b>ACTIVE</b>
<b>Unit # 303: Along chimney chase/center of living room/hallway near smoke detector/bedroom hall</b>	<b>ACTIVE</b>
<b>Unit # 304: Hallway</b>	<b>ACTIVE</b>
<b>Unit # 305: Bathroom fan</b>	<b>ACTIVE</b>
<b>Unit # 310: Hallway near smoke detector/in front of the master closet</b>	<b>ACTIVE</b>
<b>Unit # 309: Bedroom hallway</b>	<b>ACTIVE</b>
<b>Unit # 308: Bedroom hallway</b>	<b>ACTIVE</b>
<b>Unit # 307: Hallway near smoke detector</b>	<b>ACTIVE</b>
