Mr. & Mrs. Smith  
3718 W. Dravus St. Seattle, WA 98199

RE: Limited Condition of Building Survey: 5443 Any Ave W. Seattle, WA.

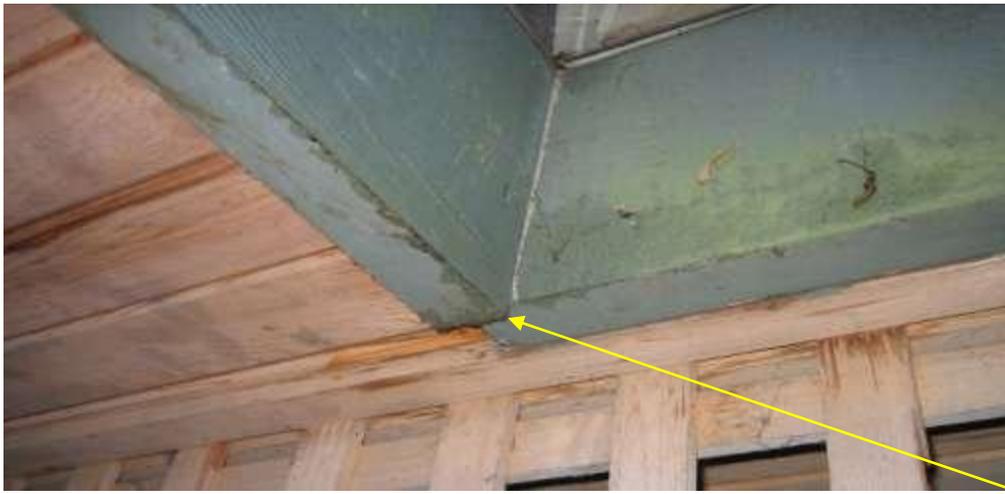
However, a few areas of concern on the rail system were noted. The first is the area where the rail caps meet the sidewalls of the structure. Because of the window configuration the deck rail overlaps the windows framing in some areas creating a void that could allow water migration into the wall system. The second area of concern is the area of the water migration damage to the deck sheathing materials visible at the lower corners of the first floor decks where the deck system meets the sidewall of the house and at the first floor south side deck where the rail meets the window system.

**Figure 1: The damaged sheathing material is located directly behind the lowest trim board on the deck structure.**

The repair suggested at this time is to properly caulk all deck railing to sidewall connections paying particular attention to the rail to window areas, all sidewall shake to corner boards, and at all lower drip cap flashing corners where the deck meets the kick out of the house.

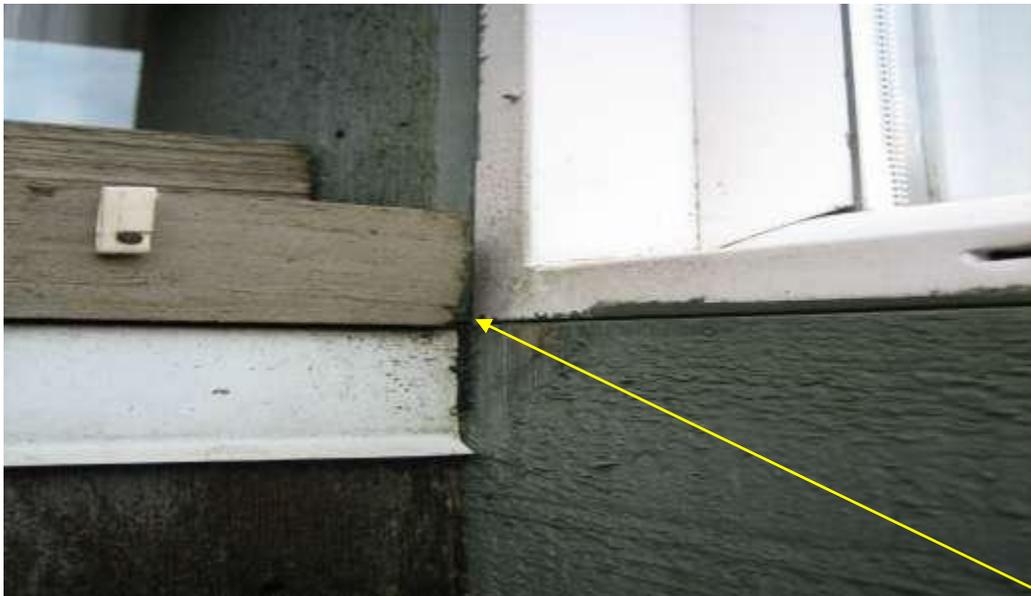
**Figure 2: The deck rail system is installed directly adjacent to the window framing. This creates a void at the top of the rail system that could, over time allow water migration into the wall system.**

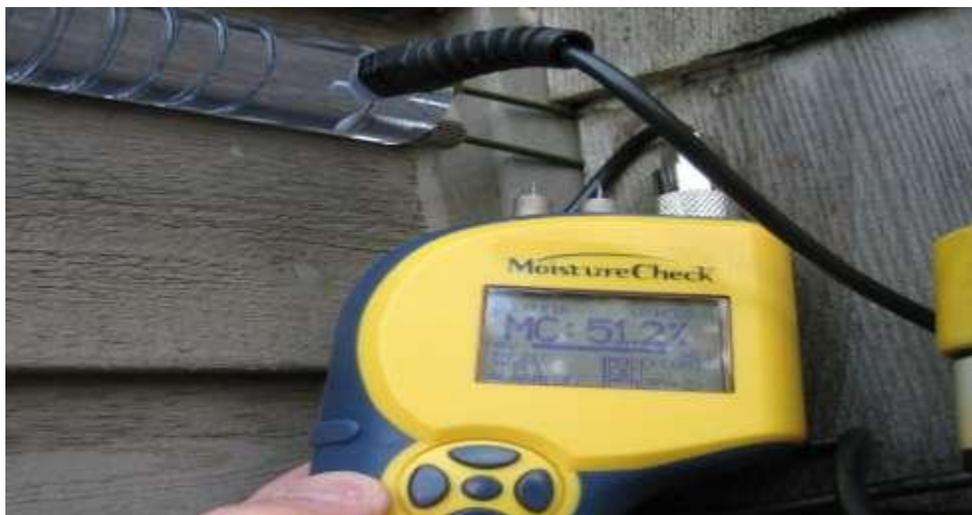
The south lower deck shows signs of water migration at the top of the deck rail where the window meets the railing; this area had a moisture content of 51.2%. Some limited areas of damaged sheathing material were found along the siding to corner board joint. This damage does not extend out into the wall system or down to the deck joist system.

**Figure 3:** The only area of high moisture content related to the deck rail cap joint was at the lower south side deck. This is the deck with the most exposure to driven rain. Minor damage to the sheathing material was noted in the area.

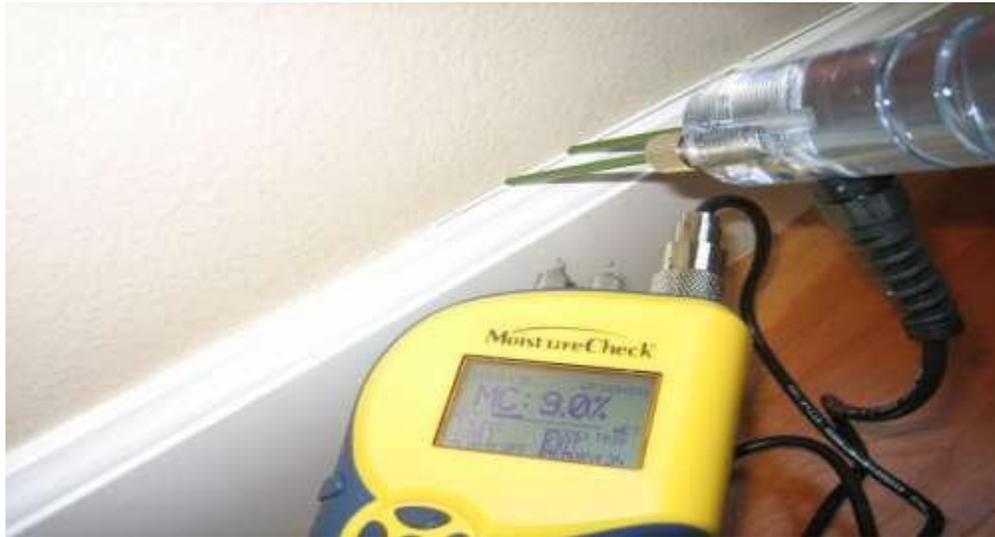
**Figure 4:** This deep wall probe is inserted directly inside and below, at the sill plate, the probe in the photo above. The 9% MC reading confirms that the moisture from deck rail outside has not entered the wall cavity.

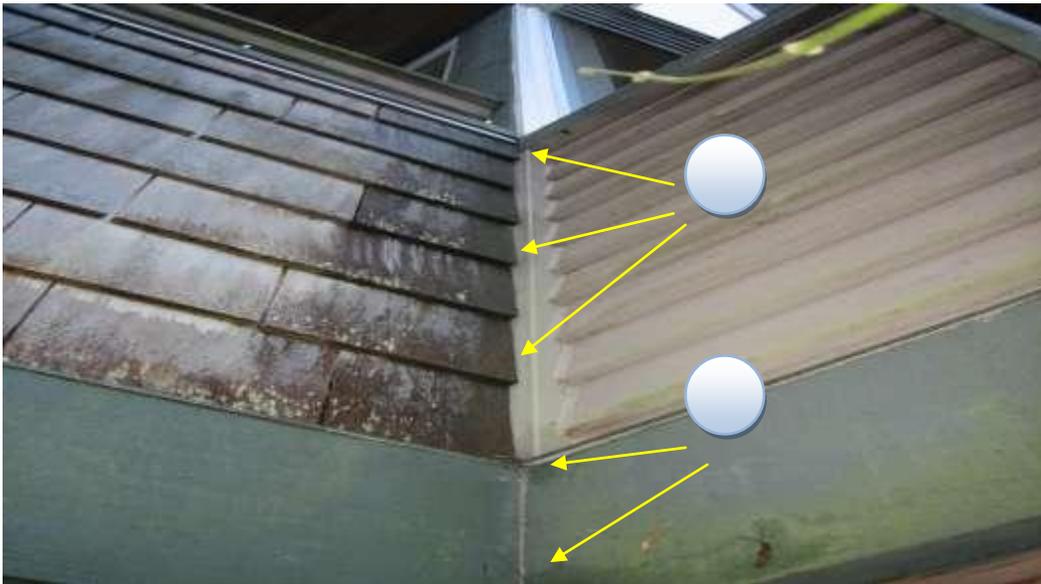
The north lower deck shows the most sever damage to the sheathing material at the bottom trim board. As seen in the photos below the damage stops at the top of the lower trim board and does not extend up the wall system.

**14.8%**

42.7%

**Figure 5:** This photo shows the moisture readings at the south corner of the first floor north side deck. The moisture readings confirm that the water migration damage to the sheathing material was caused by the faulty drip cap flashing at the top of the trim board not by water migration into the wall system from the rail cap or sidewall connection above. The heavy mildew growth at the sidewall shakes and bevel board siding appears to be from a lack of direct sun on this wall so the wall does not dry not from excessive runoff at the rail cap.

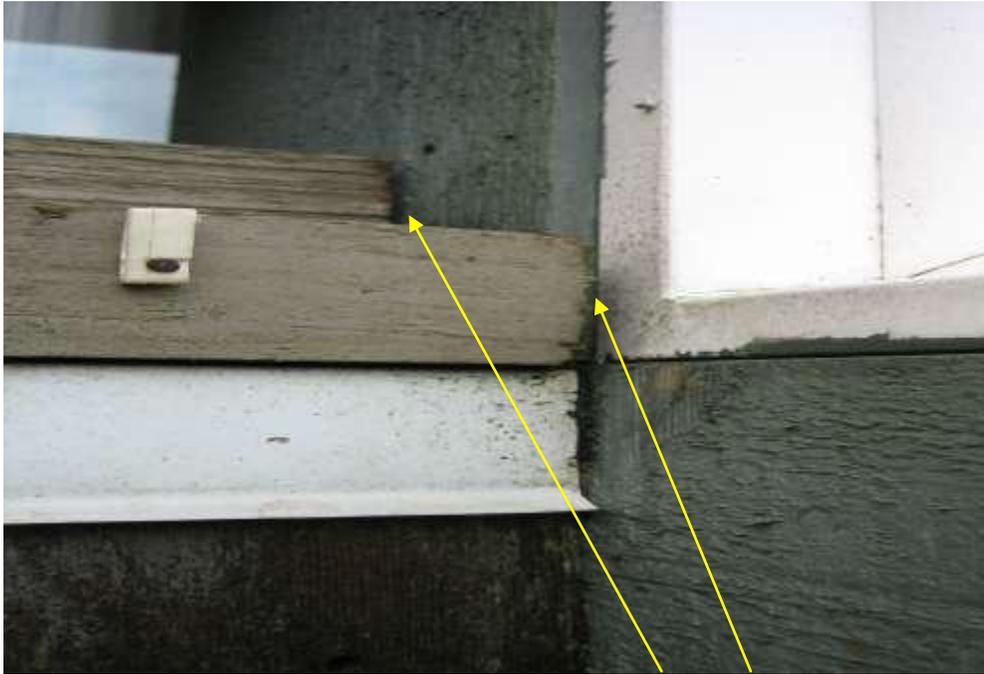
**Figure 6: The most critical caulking joint is at the deck rail to window and sidewall all decks. This area should be filled with a commercial grade caulking material.**
