INSPECTION SERVICES NORTHWEST

CONFIDENTIAL INSPECTION REPORT FOR THE PROPERTY LOCATED AT:
4210-4250 Martin Way, Olympia, WA

INSPECTION COMPLETED ON: SEPTEMBER 13, 2011

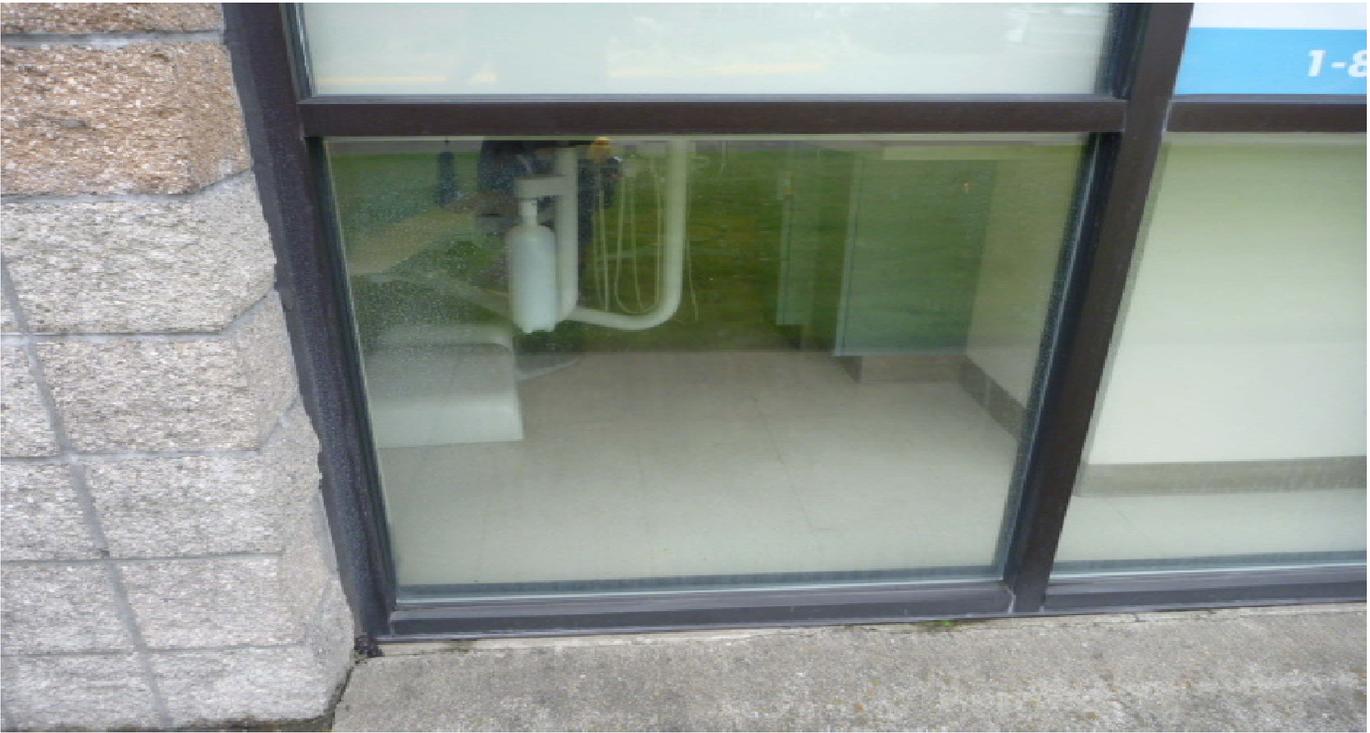
Although difficult to see in this picture the sprinkler system is damaging the glass at the lower panes because it has been directing water into the windows when the irrigation system runs.

THE IRRIGATION SYSTEM MUST BE PROPERLY ADJUSTED TO DIRECT ALL WATER AWAY FROM THE WINDOW SYSTEMS. THE SYSTEM IS SATURATING SIDING AND TRIM AND DAMAGING THE FIRST STORY FRONT GLASS IN SOME AREAS.

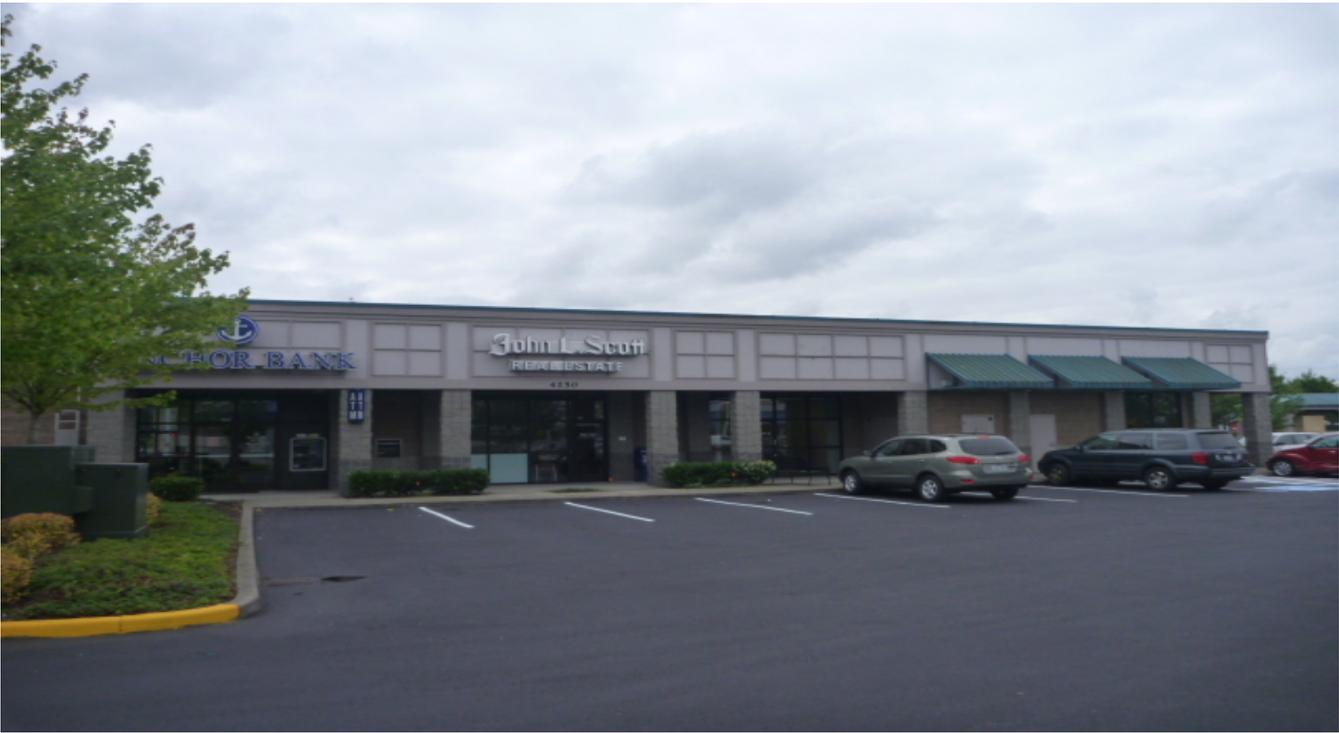
The parking area has been recently seal coated and restriped.

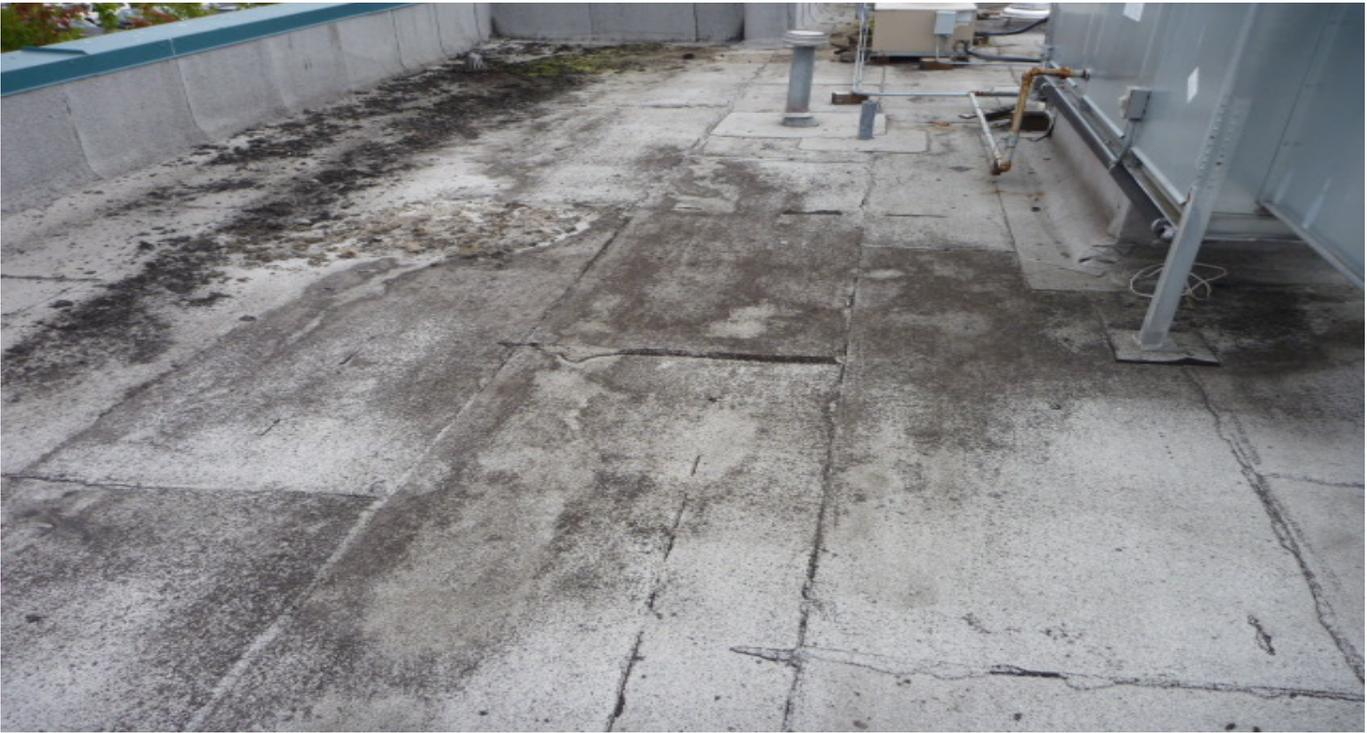
An area of concern at the roofing system, as noted in the roof section of the report, is the de-granulation of the roofing at the east end of the west building. This area of the roof will have to be replaced at this time.

REPLACE ALL DE-GRANULATED ROOFING MATERIAL AT THE NORTHWEST CORNER OF THE WEST BUILDING. APPROXIMATELY A 20' X 20' AREA.

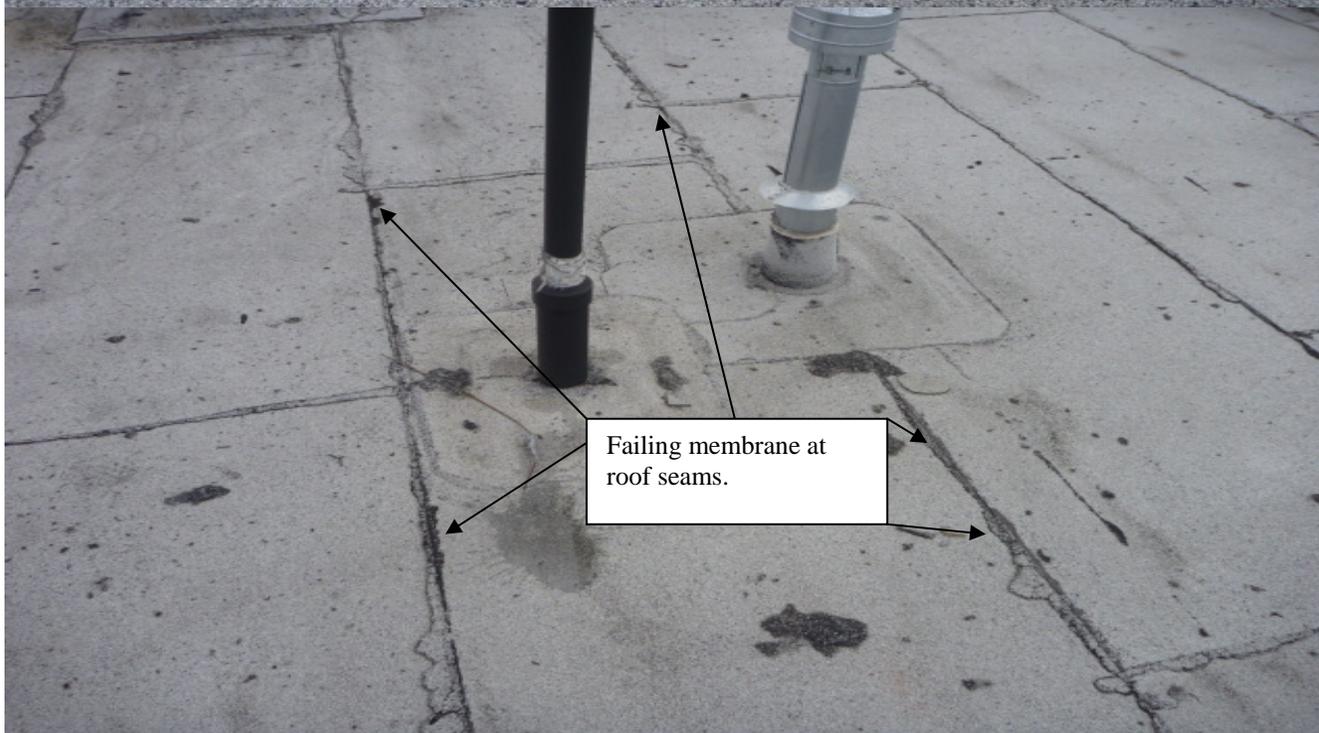
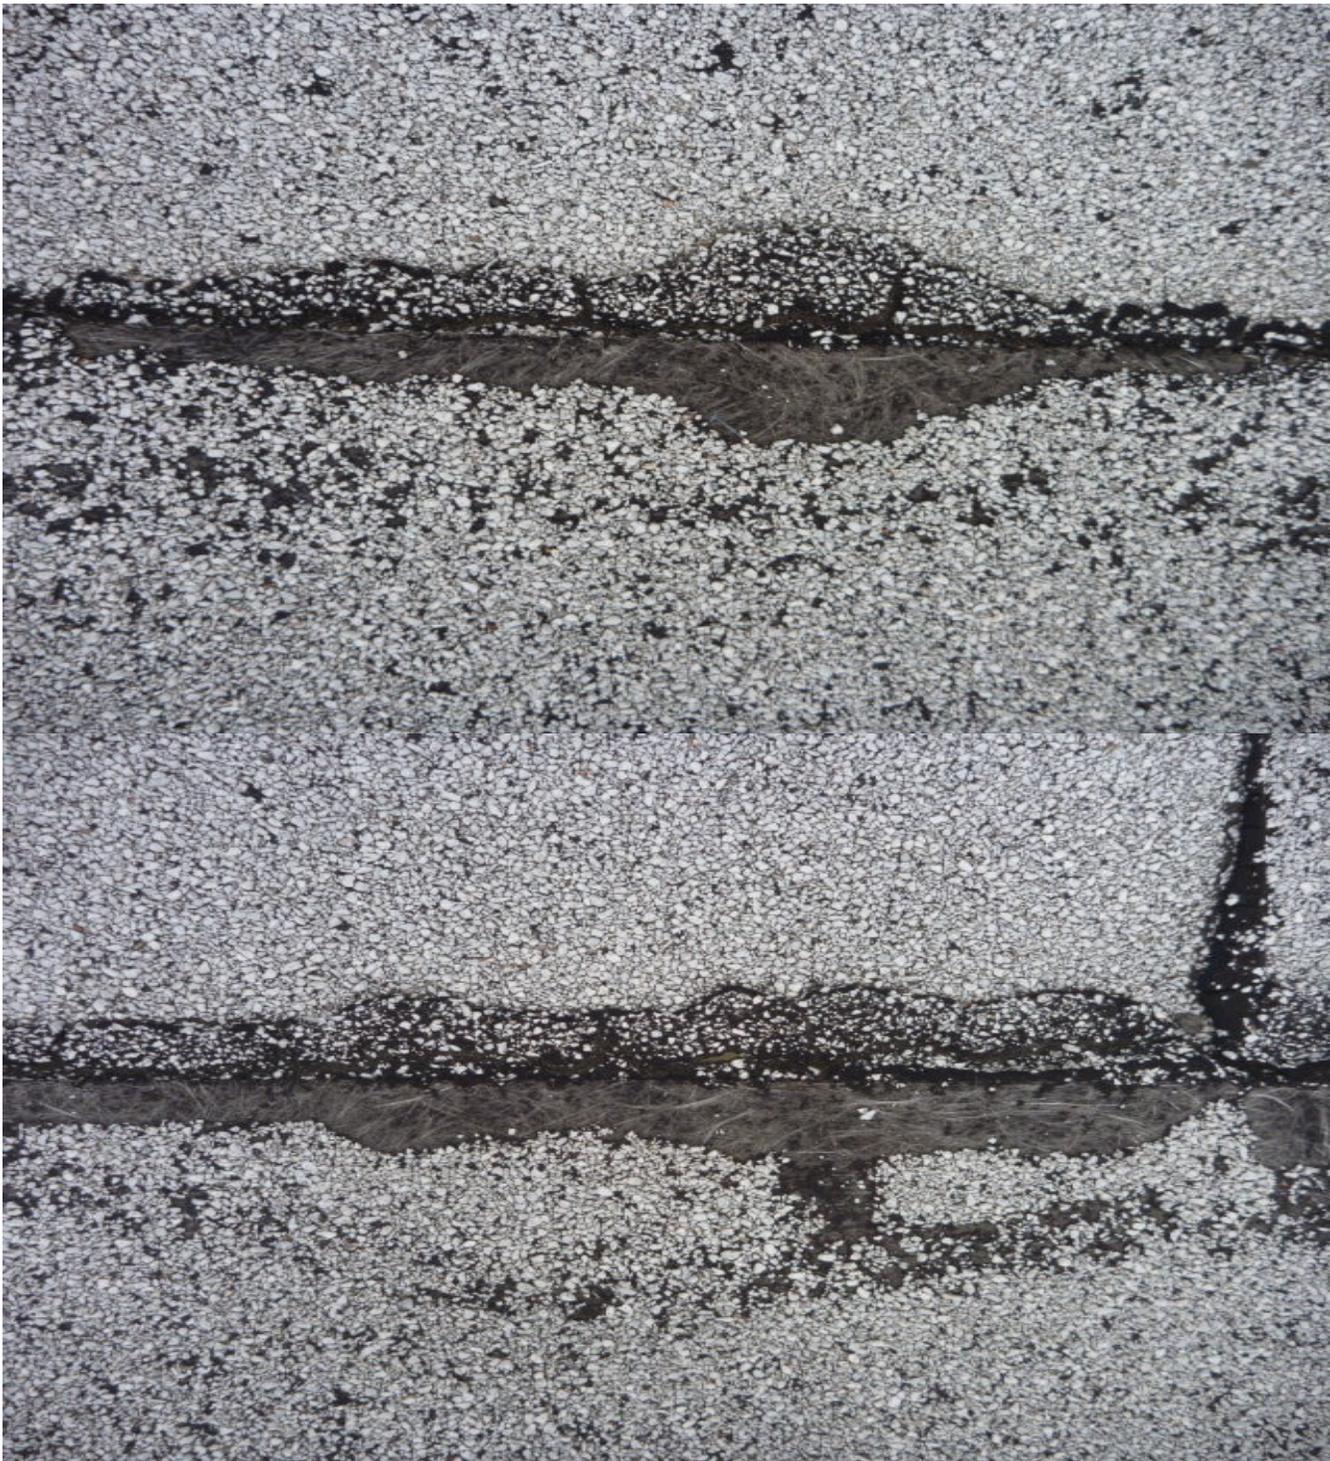
Another area of concern is at the torchdown seams in some areas of both roofs. These areas appear to have been over heated at the time of installation, this has caused a premature failure of the roofing localized at the seams. A roofing contractor will have to determine the repairs required to ensure the effective life of the roof is not reduced.

The roofing material at the seams is prematurely failing in some areas on both roofs. The roofing must be repaired in these areas to properly protect the membrane.

DETERMINE WHY THE ROOFING IS FAILING AT THE SEAMS IN SOME AREAS OF BOTH BUILDINGS AND WHAT REPAIR AS IS REQUIRED TO ENSURE THE EXPECTED LIFE OF THE ROOF CAN BE REACHED WITHOUT PREMATURE FAILURE OF A DEGRADED MEMBRANE.

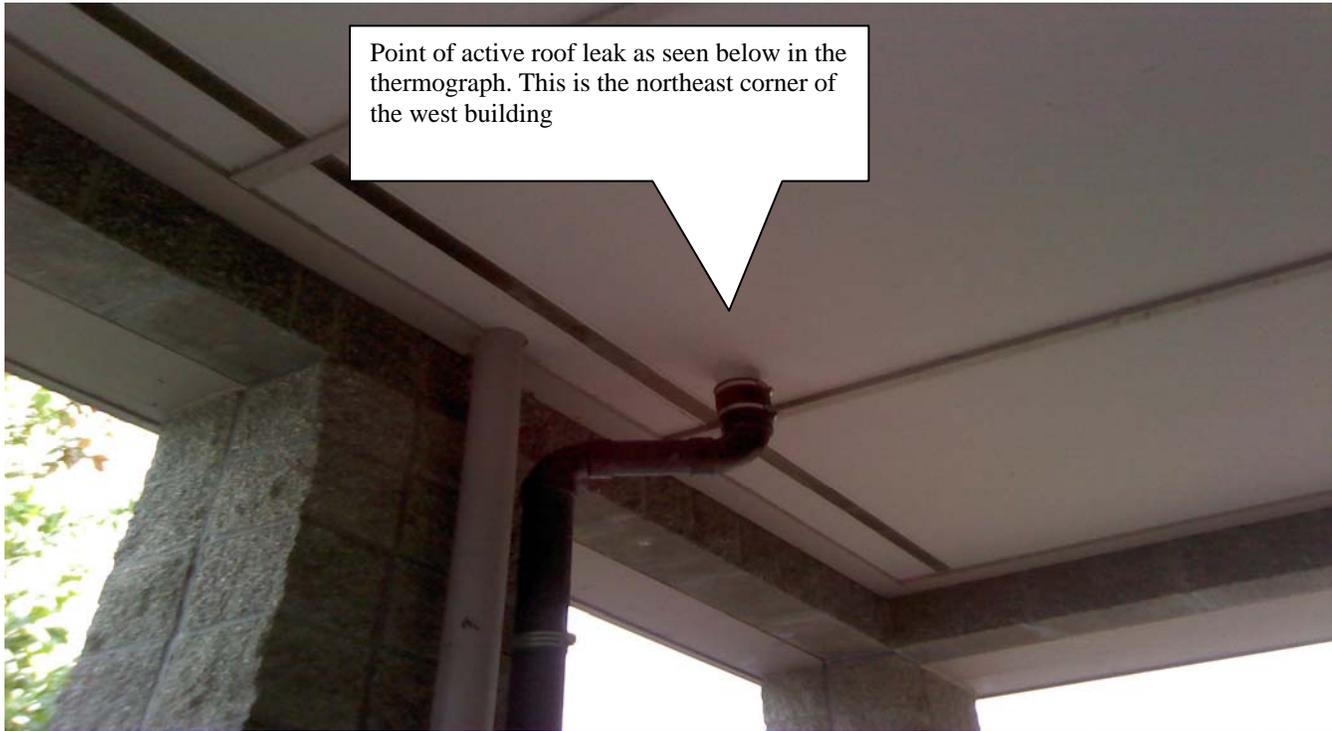
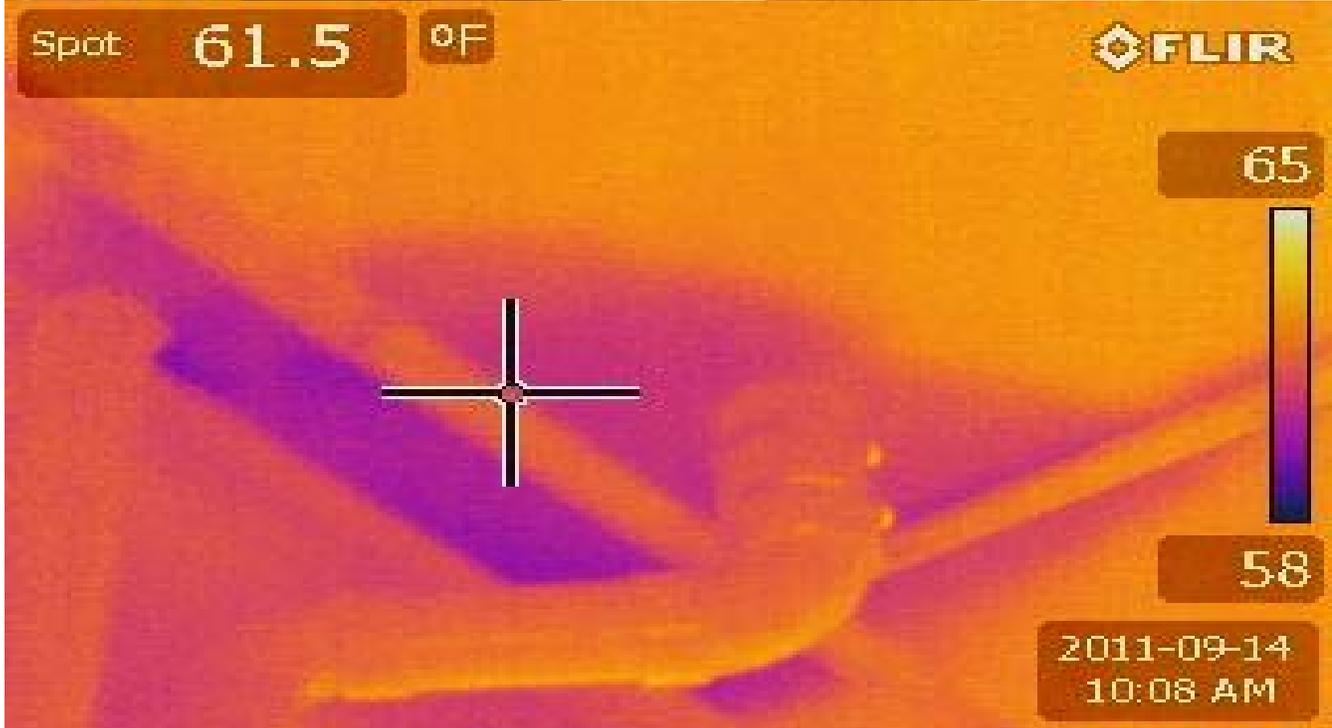
Point of active roof leak as seen below in the thermograph. This is the northeast corner of the west building

REPAIR THE ACTIVE ROOF LEAK AT THE NORTHEAST CORNER OF BRIGHT DENTAL ENTRYWAY

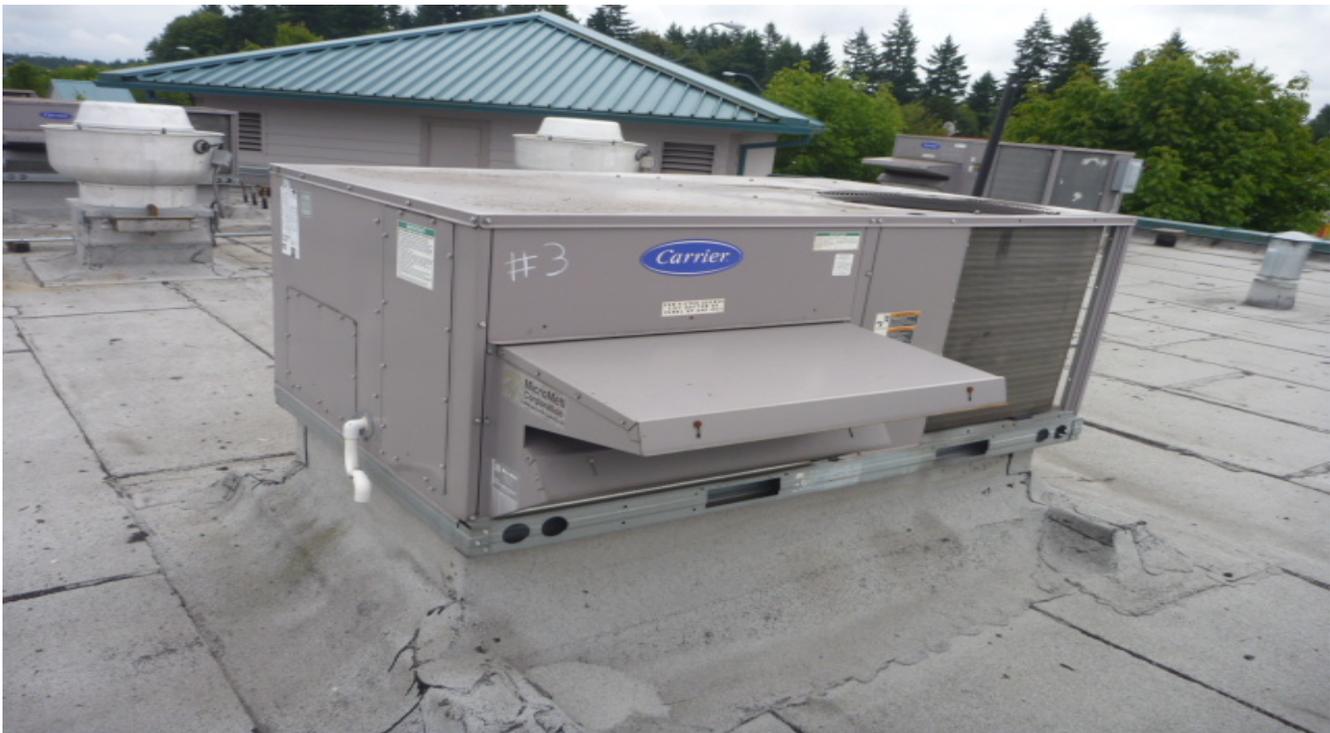
Typical roof pack HVAC unit as installed on both roof systems. There are a total of nine units.
