EIFS

What are EIFS?

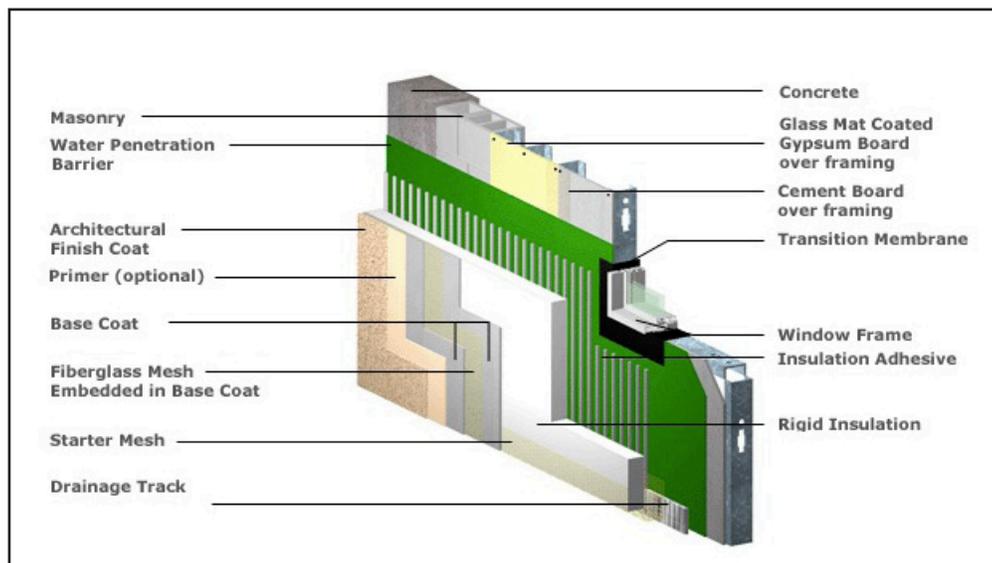
EIFS System Components

Exterior Insulation and Finish Systems (EIFS) are multi-layered exterior wall systems that are used on both commercial buildings and homes. EIFS were introduced in the U.S. almost 30 years ago and were first used on commercial buildings and then later on homes. EIFS typically consist of an insulation board made of polystyrene foam (which is secured to the exterior wall surface with an adhesive and/or mechanical attachments), a water-resistant base coat applied on top of the insulation and reinforced with fiberglass mesh and a finish coat typically using acrylic co-polymer technology. This type of system is often referred to as artificial stucco.
